Learning By Doing 2018 Aquatic Resource Monitoring Plan

Program Purpose and Objectives

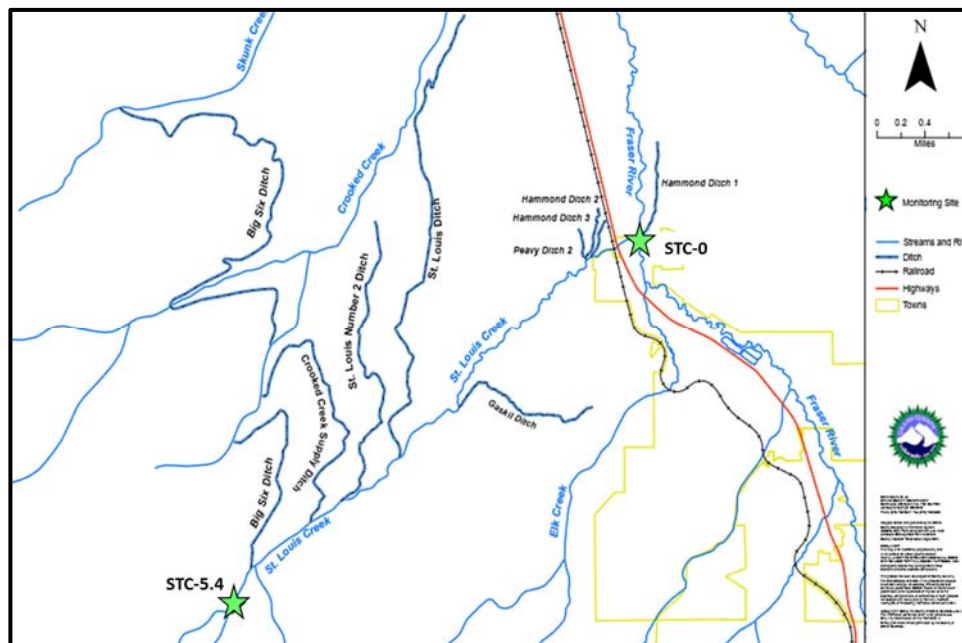
Figure 2 – New and Existing Temperature Sites in Saint Louis Creek

1. STC-5.4 – This site is in the Saint Louis Creek at the USGS Streamflow Gauge near Fraser Experimental Forest Headquarters. It is upstream of GCWIN's existing Saint Louis Creek temperature site (STC-0), as well as upstream of several irrigation diversions (Figure 2). Collection of temperature data at this site will facilitate better understanding of thermal patterns in this tributary.

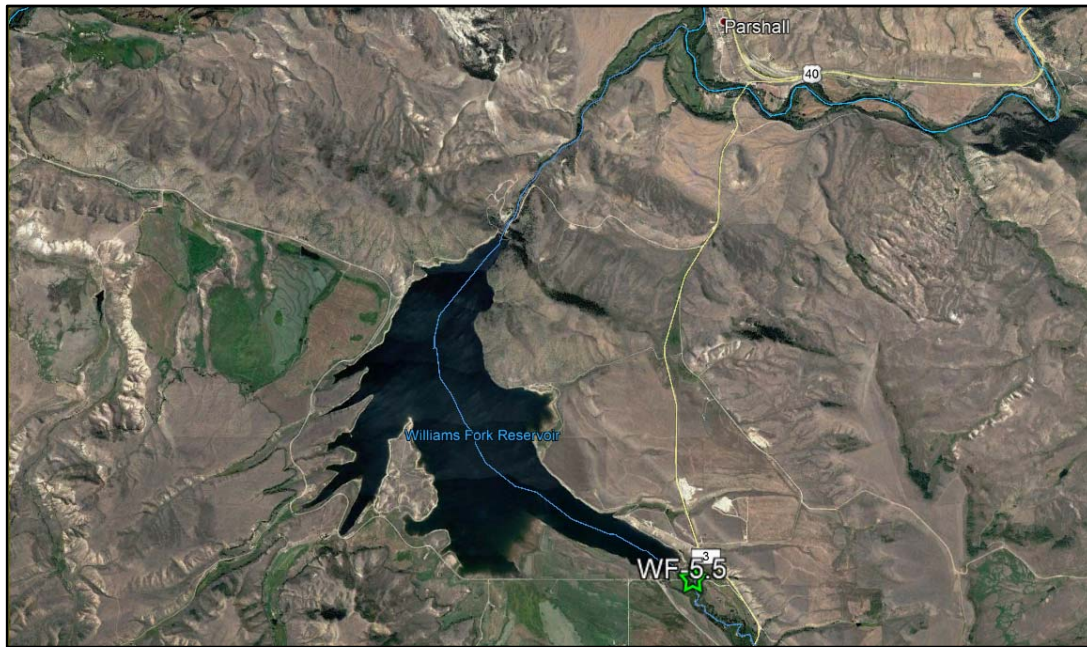
Figure 4 – New Temperature Site on Williams Fork

4. WF-5.5 – This site is located in Williams Fork upstream of Williams Fork Reservoir (Figure 4) Denver Water will be doing a river restoration project in Fall 2018 in this reach above the reservoir. The rationale for this site includes: baseline data are lacking, a temperature site would complement temperature data gathered from BLM in 2016, and it could be beneficial to establish a baseline prior to construction of the river restoration project to discern any changes over time.

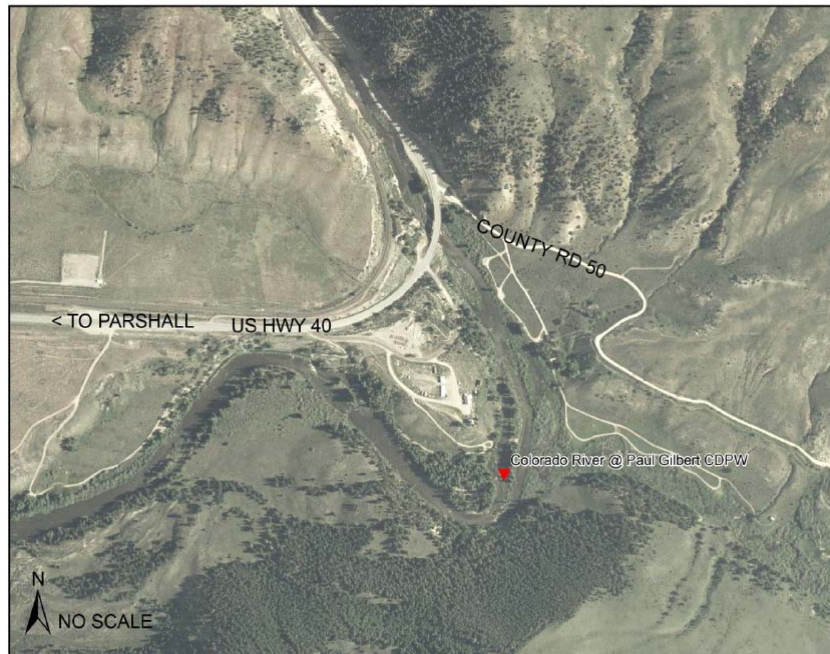
Figure 5 – CR4 Paul Gilbert Core Sample Site

In 2018, the Colorado River was anticipated to contain 80% of average flows. Therefore, core samples will be collected on the Colorado for the first time in several years at three sites in the CR4, CR5, and CR6 reaches (Table 3). Core samples will not be collected on the Fraser River and Ranch Creek since both streams exceeded flushing flow recommendations during runoff. Six core samples will be collected in each reach. Pebble counts will also be conducted at the three core sample sites for assessment of the spawning habitat.

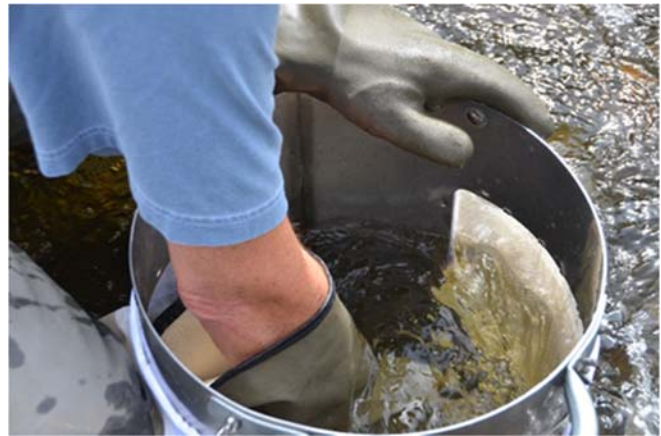
- Sampling occurs during the period from late September to early October (fall) to target macroinvertebrate communities during annual periods of high density. This sampling period is consistent with the Colorado Water Quality Control Division's methodology for macroinvertebrate sampling (Colorado Department of Public Health and Environment, 2010).
- Timberline Aquatics collects the samples utilizing protocols approved by the Division's *Section 303(d) Listing Methodology 2018 Listing Cycle* (Colorado Department of Public Health and Environment, Water Quality Control Division, March 2017). Three quantifiable Hess samples will be taken from riffle habitat at each of the sites. Each sample is taken from an area of similar size substrate and velocity (if possible) to avoid any bias from these physical parameters when making comparisons among sites.

Figure 11 - Sample Collection with a Hess Sampler
