**Subject:** 2018 Substrate Monitoring, Grand County Colorado

## INTRODUCTION/PURPOSE

The purpose of this technical memorandum is to report on the 2018 monitoring efforts which include tasks I through III, as described below. The field sampling, data collection and results are undertaken in support of the draft Grand County Stream Management Plan (SMP) (Tetra Tech et al. 2010) and the “Learning By Doing” (LBD) Cooperative Effort.

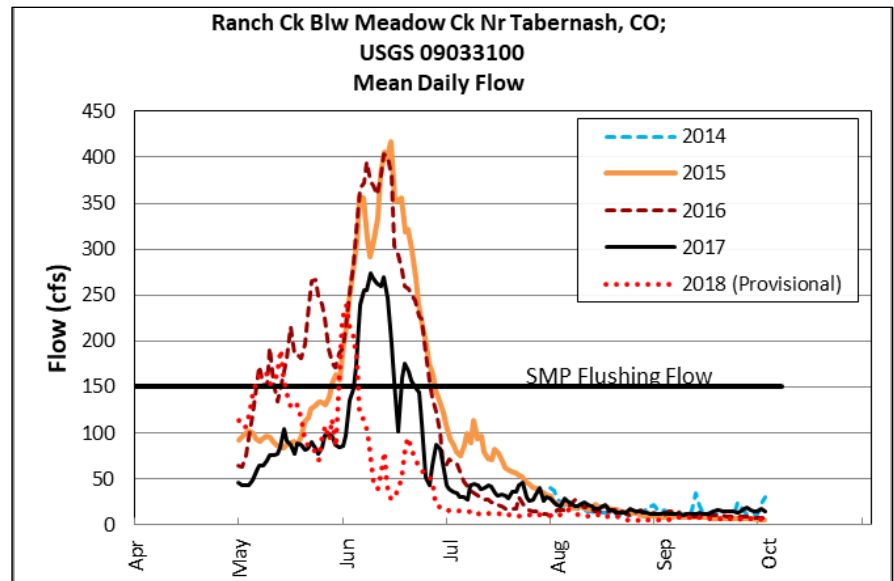
Figure 2. Streamflow hydrographs for Fraser River at Winter Park, Fraser River at Granby, and Ranch Creek blw Meadow Creek.

2018 streamflow hydrographs for the April through September period are presented in **Figures 2 and 3** for eight gage stations in the Fraser and Colorado River watersheds of Grand County. Comparisons of 2018 with previous monitoring years are included. Annual peak flows for the Fraser River, Ranch Creek and the Colorado River over the monitoring period are compared in **Table 4** with the flushing flow recommendations contained in the SMP (TetraTech et al. 2010). The durations that flows exceeded the flushing flow recommendations are also presented.

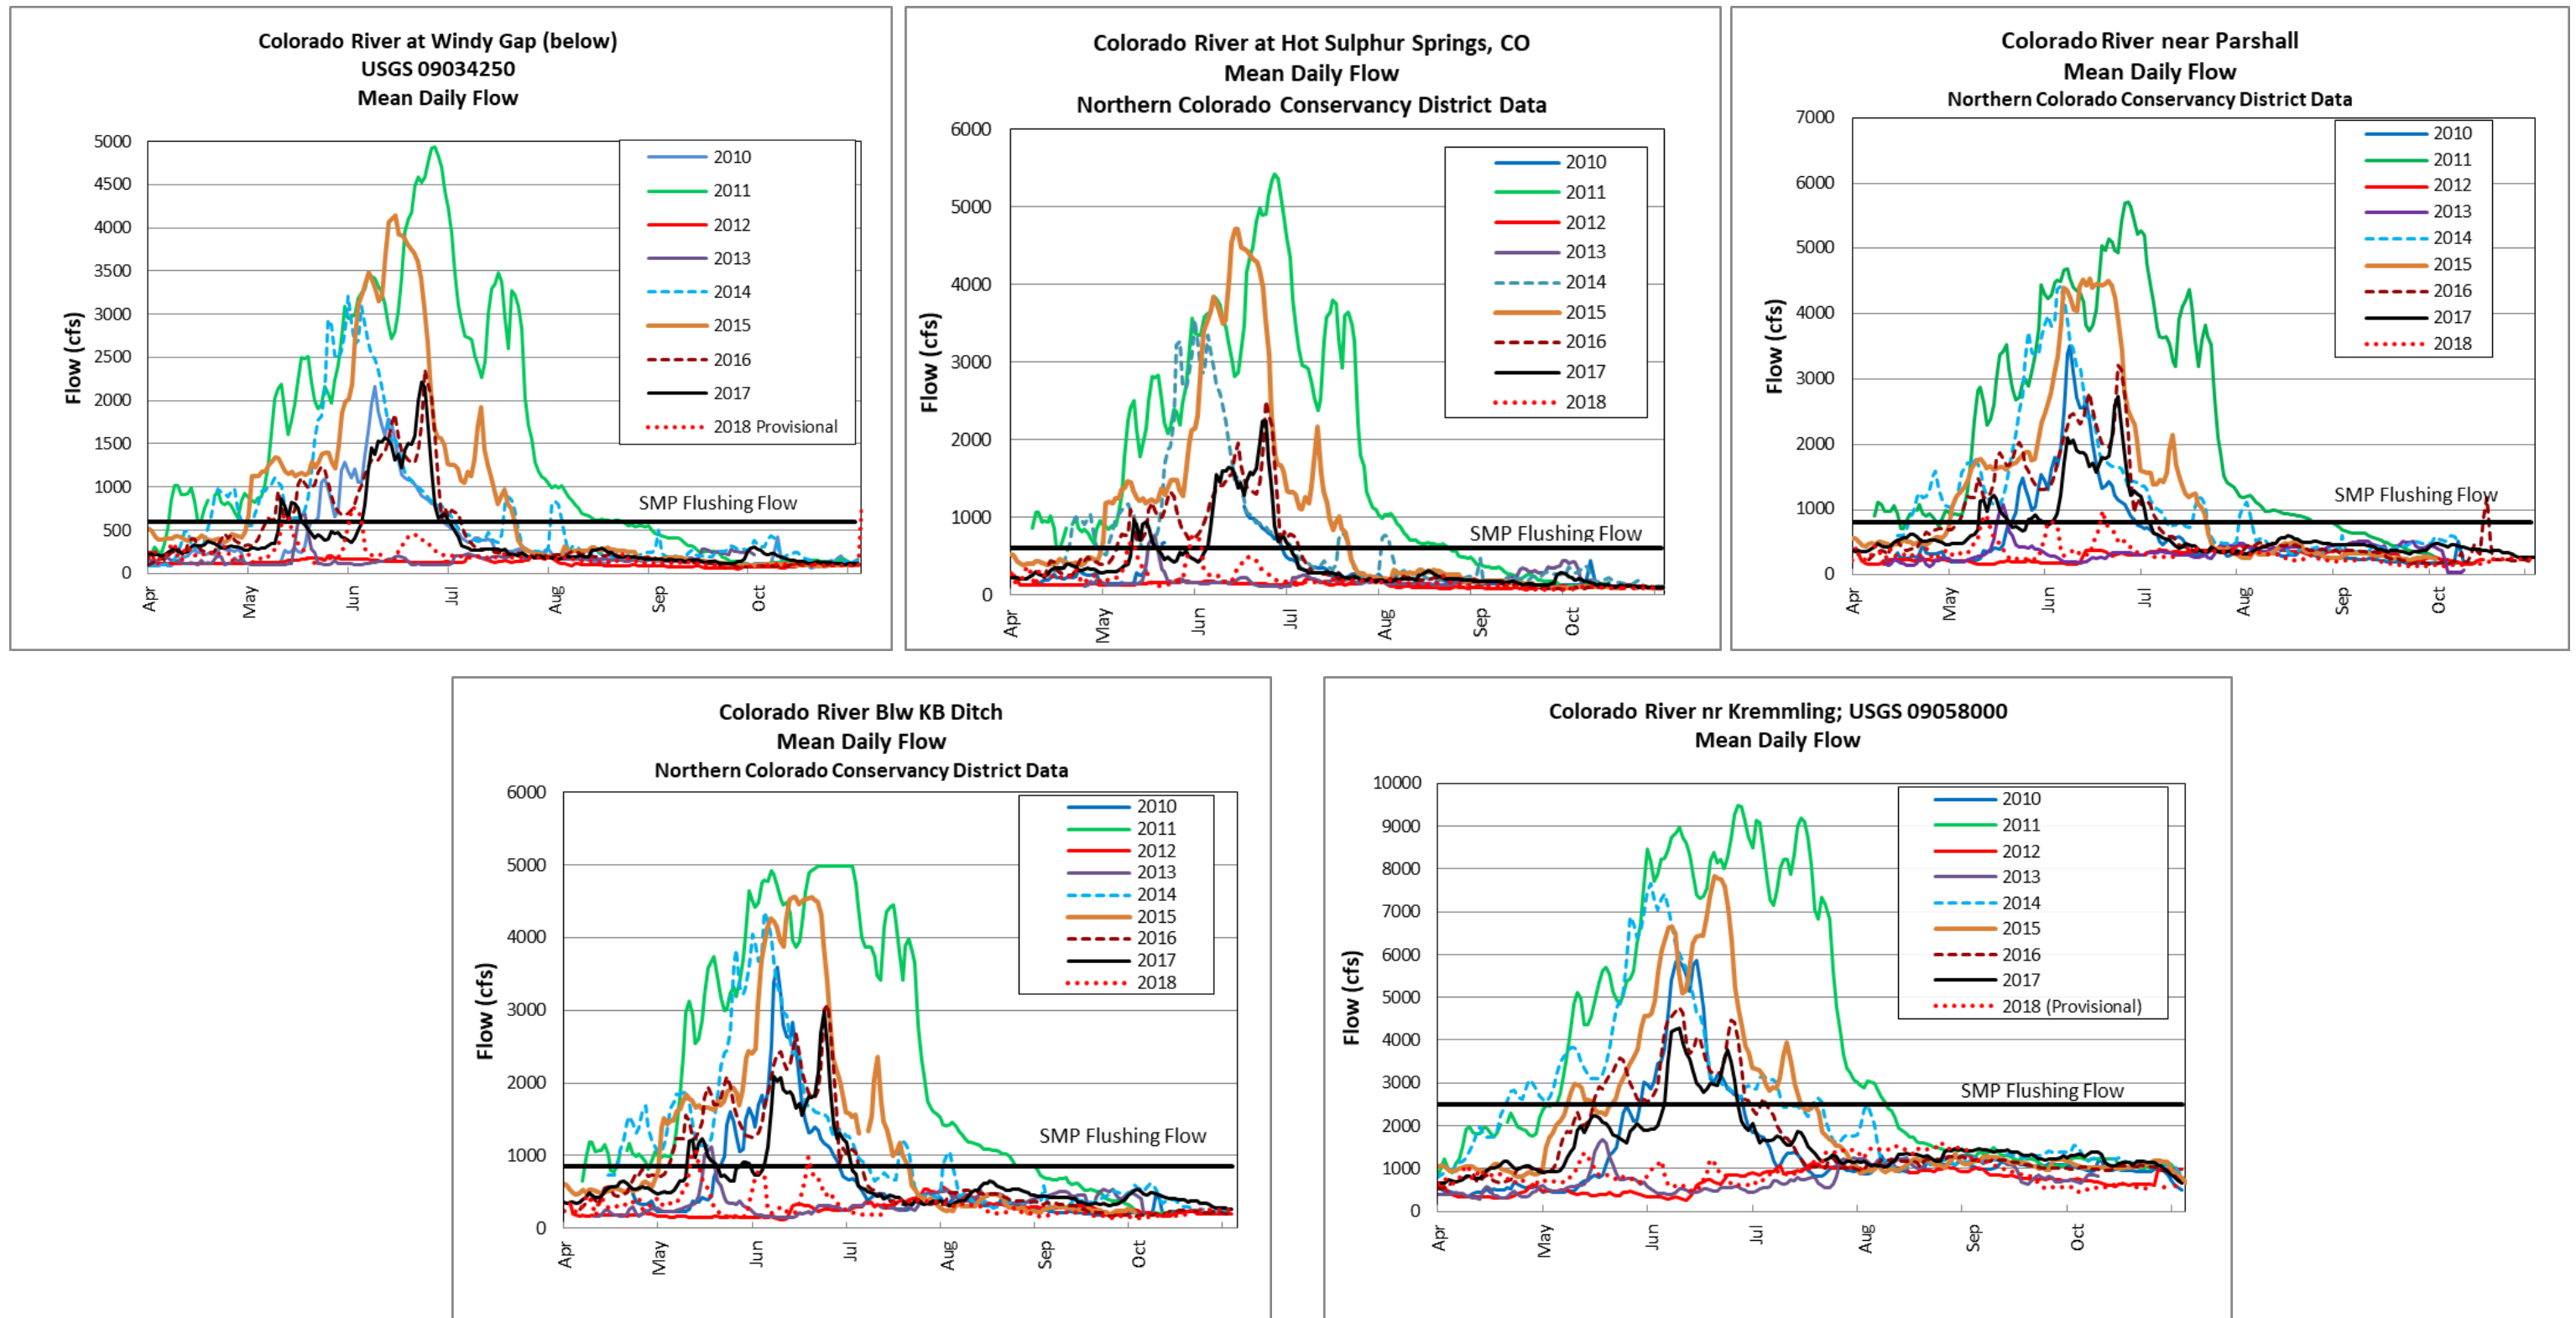
Figure 3. Hydrographs for Colorado River at Windy Gap (below), Colorado River at Hot Sulphur Springs, Colorado River near Parshall, Colorado River blw KB Ditch, and Colorado River nr Kremmling.

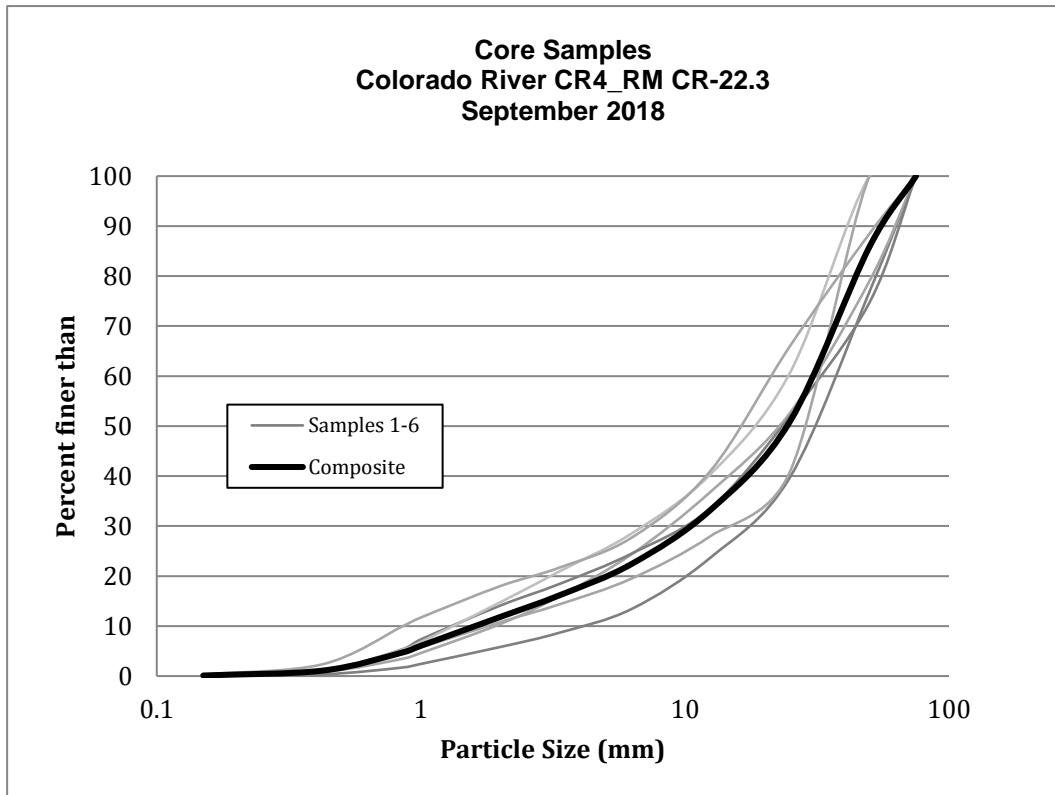
Figure 4. Particle size distribution of the six McNeil-Ahnell core samples collected from Colorado River at site CR4\_RM-22.3 at Pioneer Park, September 2018.

Particle size distributions for individual core samples collected at the three Colorado River spawning bar sites in 2018 are presented in **Figures 4, 5 and 6**, while temporal comparisons of these distributions with previous monitoring years are shown in **Figure 7**. 2018 composite median particle size and percent less than 2 mm for core samples is compared among sites in **Figure 8**, while temporal comparisons with previous monitoring years are presented in **Figure 9**. Results of the 2018 spawning bar pebble counts, including embeddedness, are presented in **Table 5**. Spatial and temporal comparisons of embeddedness for the three sites are made in **Table 6** and **Figure 10**.

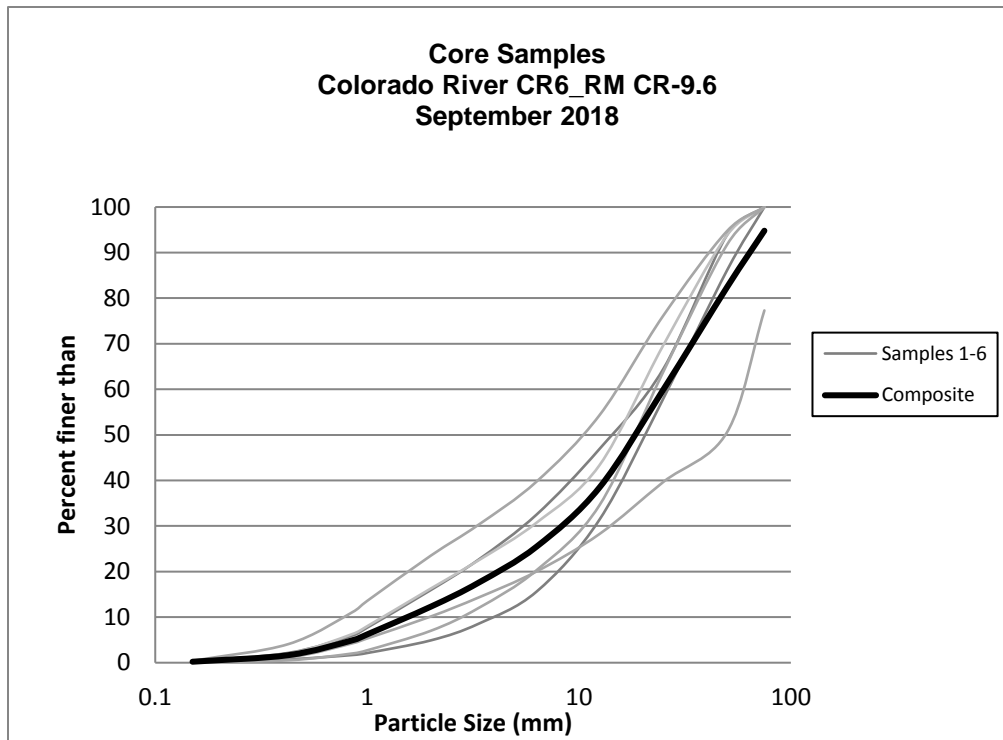
Figure 6. Particle size distribution of the six McNeil-Ahnell core samples collected from Colorado River at site CR6\_RM-9.6 at the KB Ditch, September 2018.

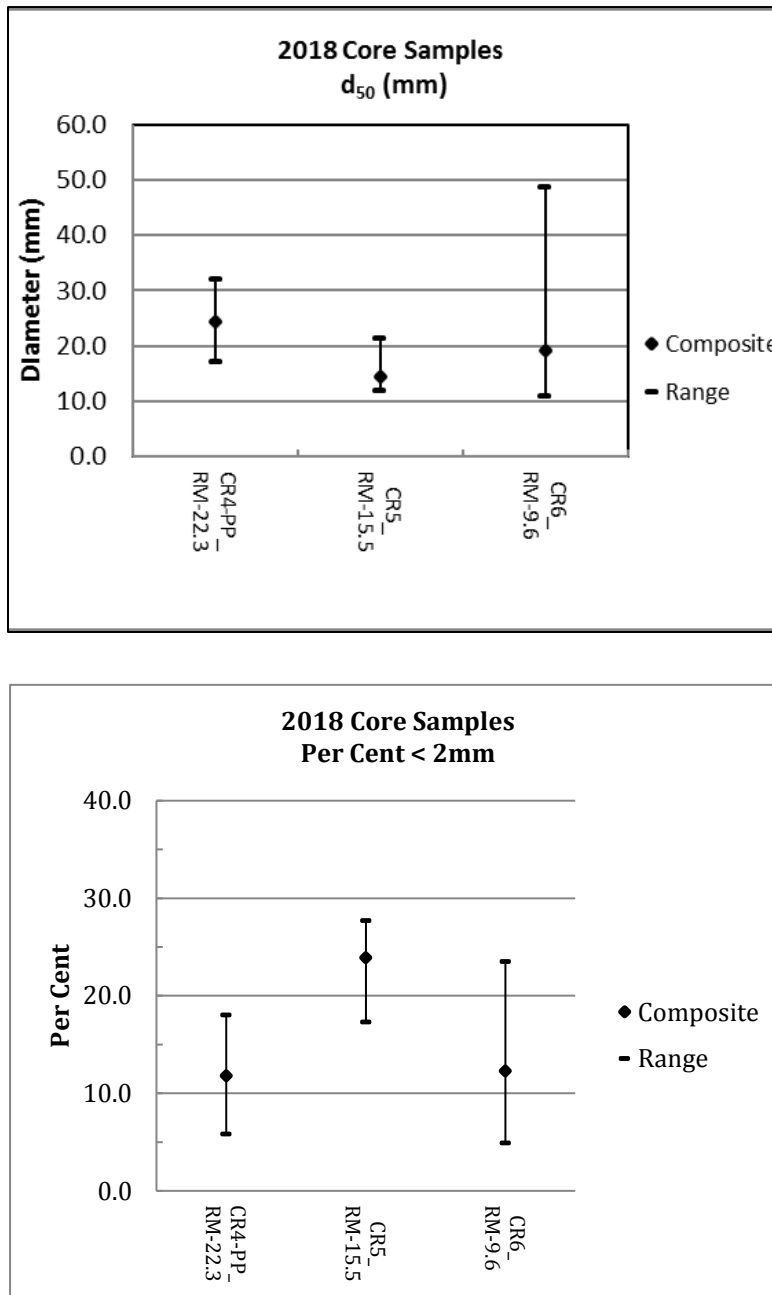
Figure 8. Composite and range of median particle sizes (d<sub>50</sub>, mm) and percentages of sediment <2mm for the six core samples collected at three Colorado River spawning bar study sites, 2018.

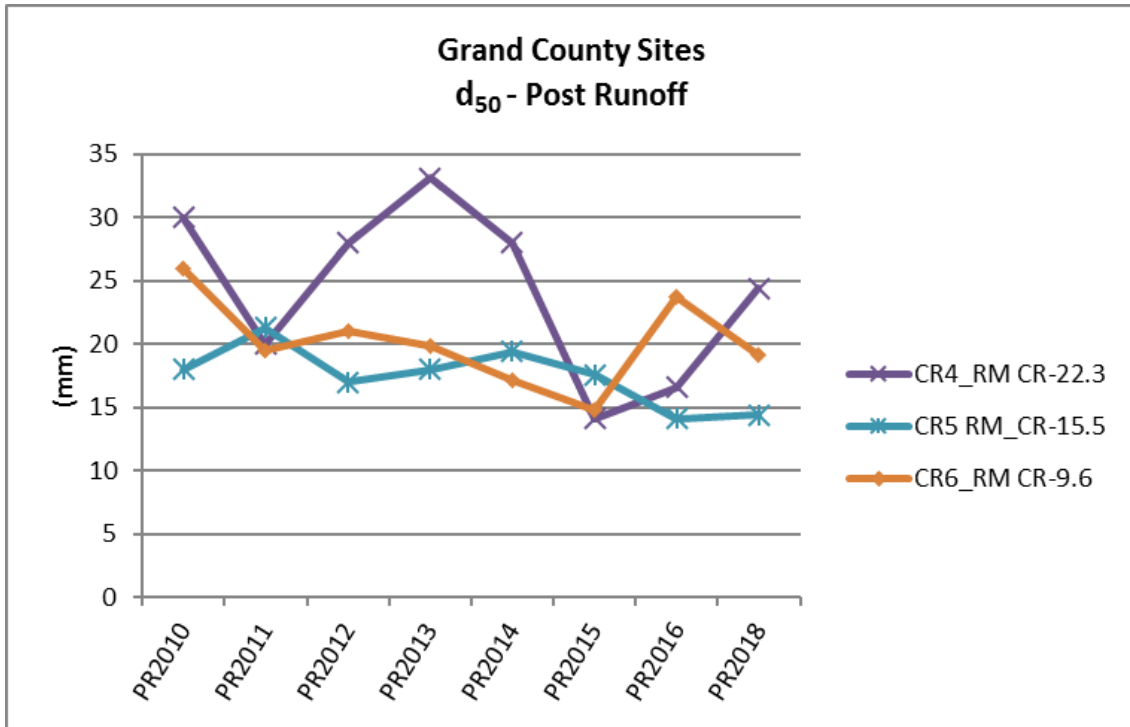
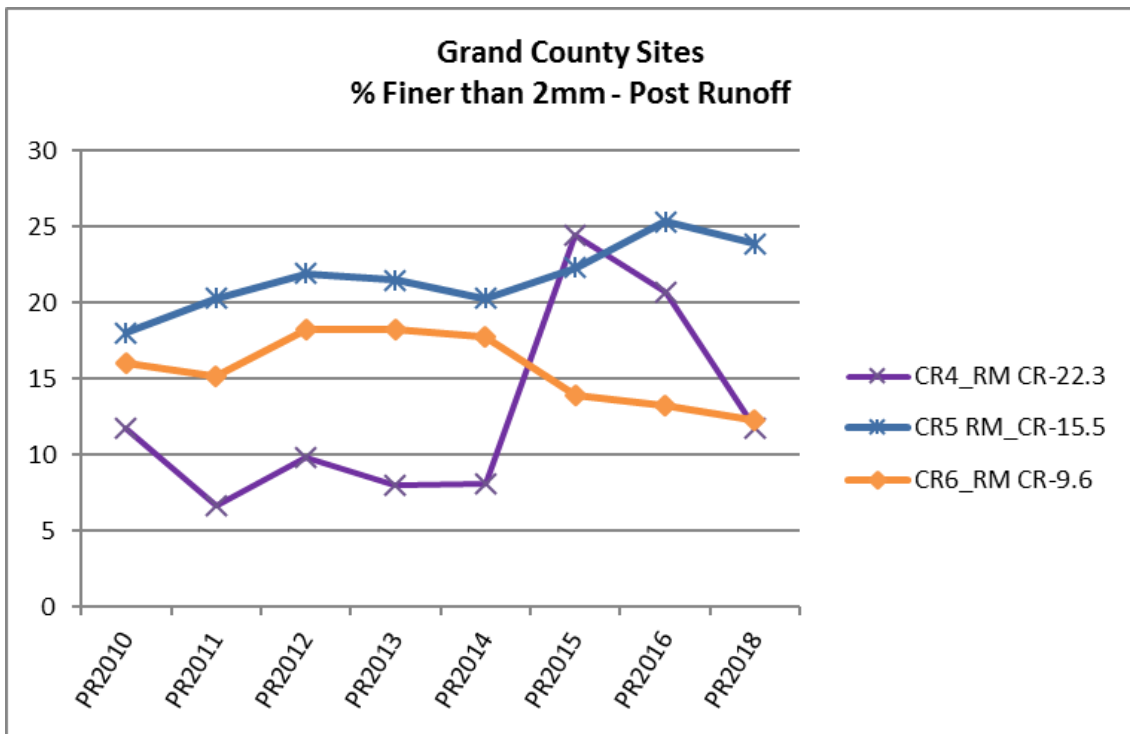
Figure 9. Comparison of composite median particle size (d<sub>50</sub>, mm) and percent finer <2mm at three Colorado River spawning bar sites, post-runoff 2010-2018.

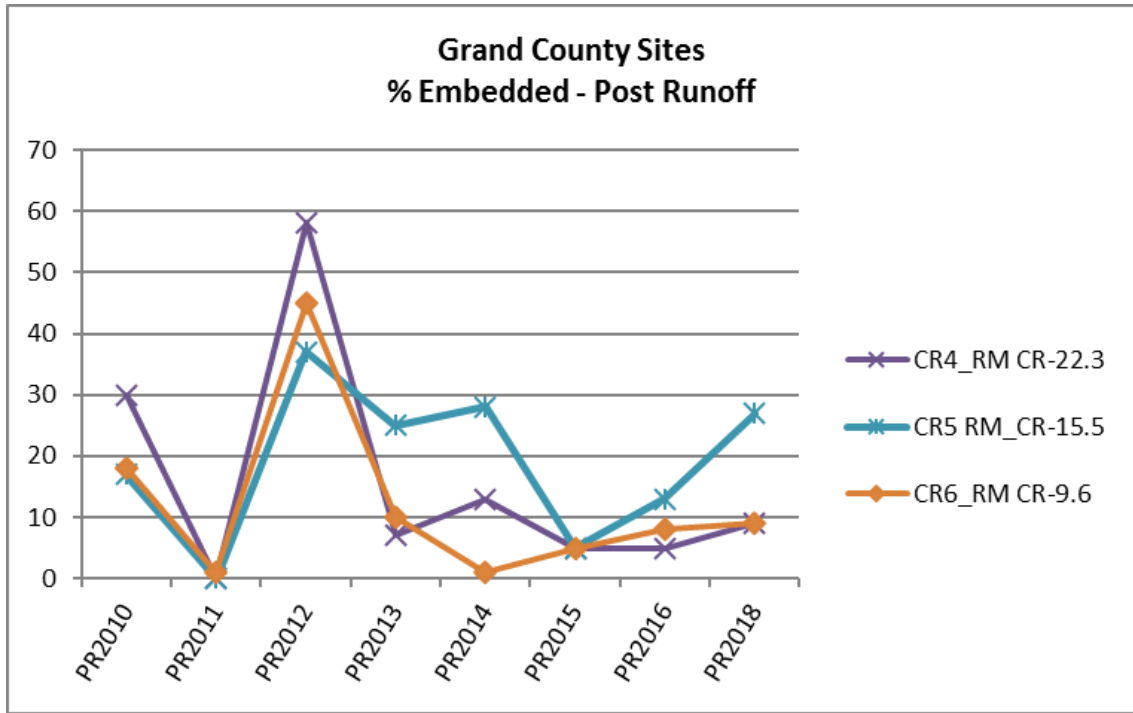
Figure 10. Comparison of % embedded substrate at three Colorado River spawning bar sites, post-runoff 2010-2018.

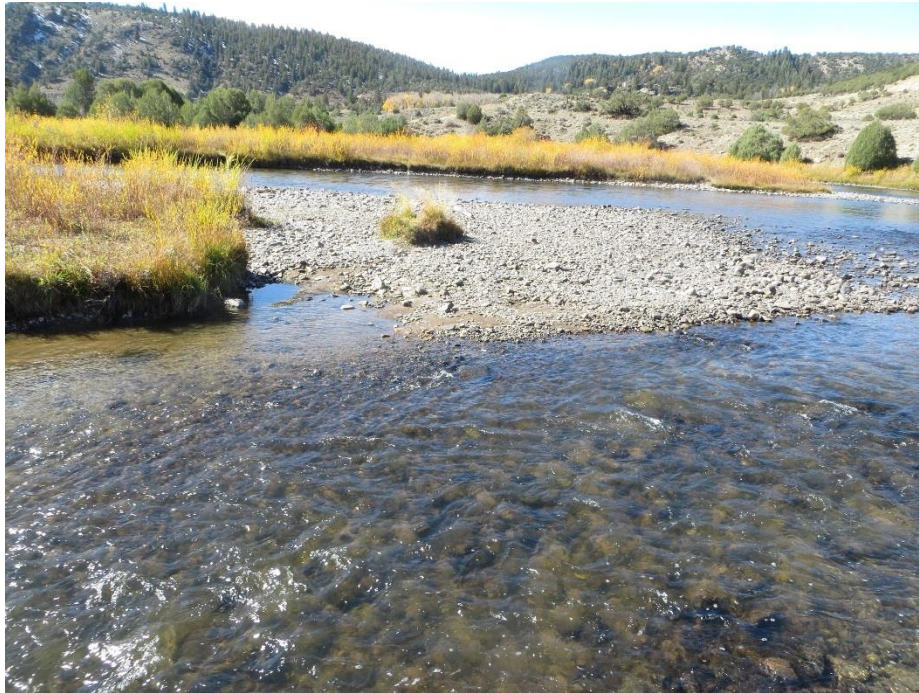
RM CR-(9.6)  
Colorado River, CR7.  
Sample date: October 7, 2018

Colorado River, CR7, looking at bar for pebble count.
